# Manhole Inspection Summary

Manhole # S290\_\_004MH

Insp Date: **4/13/09 9:40 AM**

**Location** Address: **801 W CROSS ST**

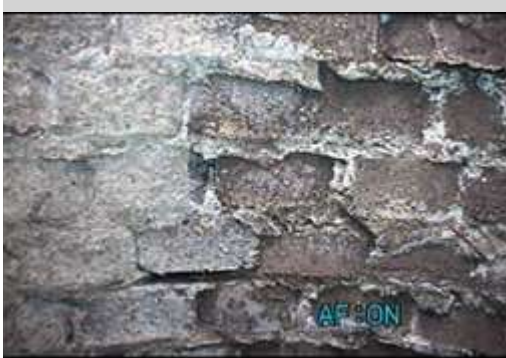
Miscellaneous

corbel wall

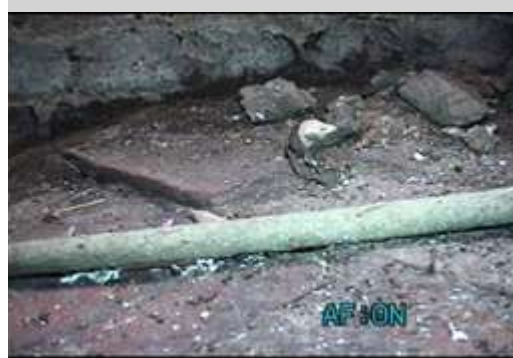
Miscellaneous

debris bench

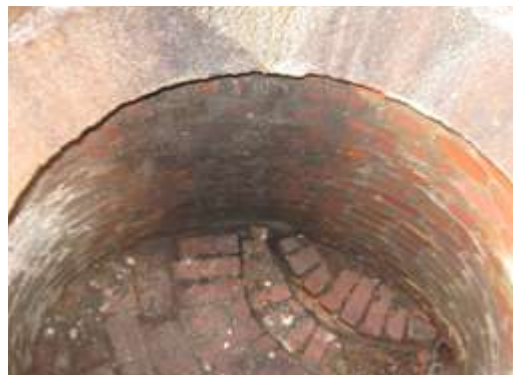
Defect 1

**Frame** Offset: **0** (in.) Condition: ☐ Sound ☐ Cracked ☒ **Leaks**

FRAME/LID INFILTRATION

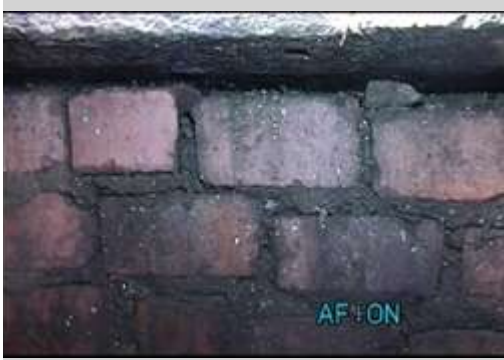
Defect 4

Infiltration: ☐ None ☒ **Joint** ☐ Cracks ☐ Mortar ☐ Roots ☐ Wall

infiltration joint chimney/frame

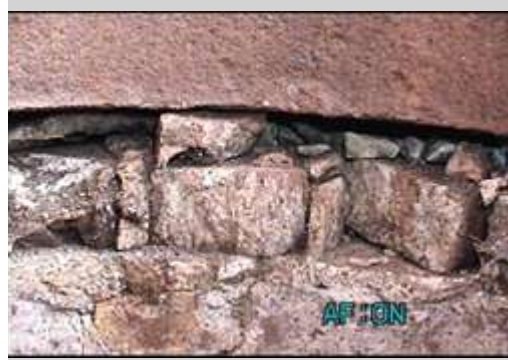
Defect 2

Condition: ☐ Sound ☐ Cracked ☐ Root Intrusion ☒ **Loose Brick** ☒ **Deteriorated**

loose bricks and deteriorated chimney

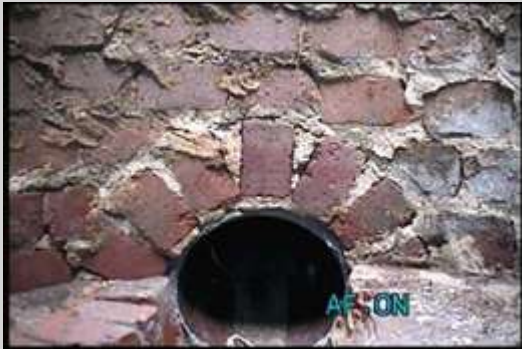
12 O'Clock Outflow

8 in. Circular Gravity Sewer  
Pipe Out @ 12 O'Clock

Pipe Height: **8.4** (in.) Rod and Bar (Angled)  
Pipe Material: **Clay** ☐ Pipe Lined  
Invert Depth: **5.28** (ft.) Flow Characteristics: **None**  
Deposits: ☒ None ☐ Mud ☐ Sludge ☐ **Debris** ☐ Grease  
Silt Depth: **0** (in.) Deposits Extent:  
Infiltration: **None** Pipe Seal Cond: **Sound**

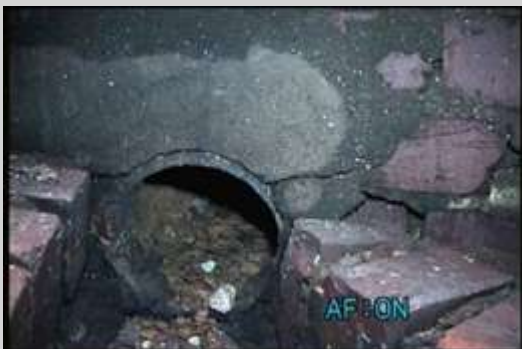
9 O'Clock Inflow

6 in. Circular Gravity Sewer  
Pipe In @ 9 O'Clock

Pipe Height: **6** (in.) Rod and Bar (Angled)  
Pipe Material: **Clay** ☐ Pipe Lined  
Invert Depth: **4.90** (ft.) Flow Characteristics: **None**  
Deposits: ☐ None ☐ Mud ☐ Sludge ☒ **Debris** ☐ Grease  
Silt Depth: **0** (in.) Deposits Extent: **Light**  
Infiltration: **None** Pipe Seal Cond: **Sound**
